*Moline Street
PCB Site*

*Removal Action
Completion Report*

Final

March 2015

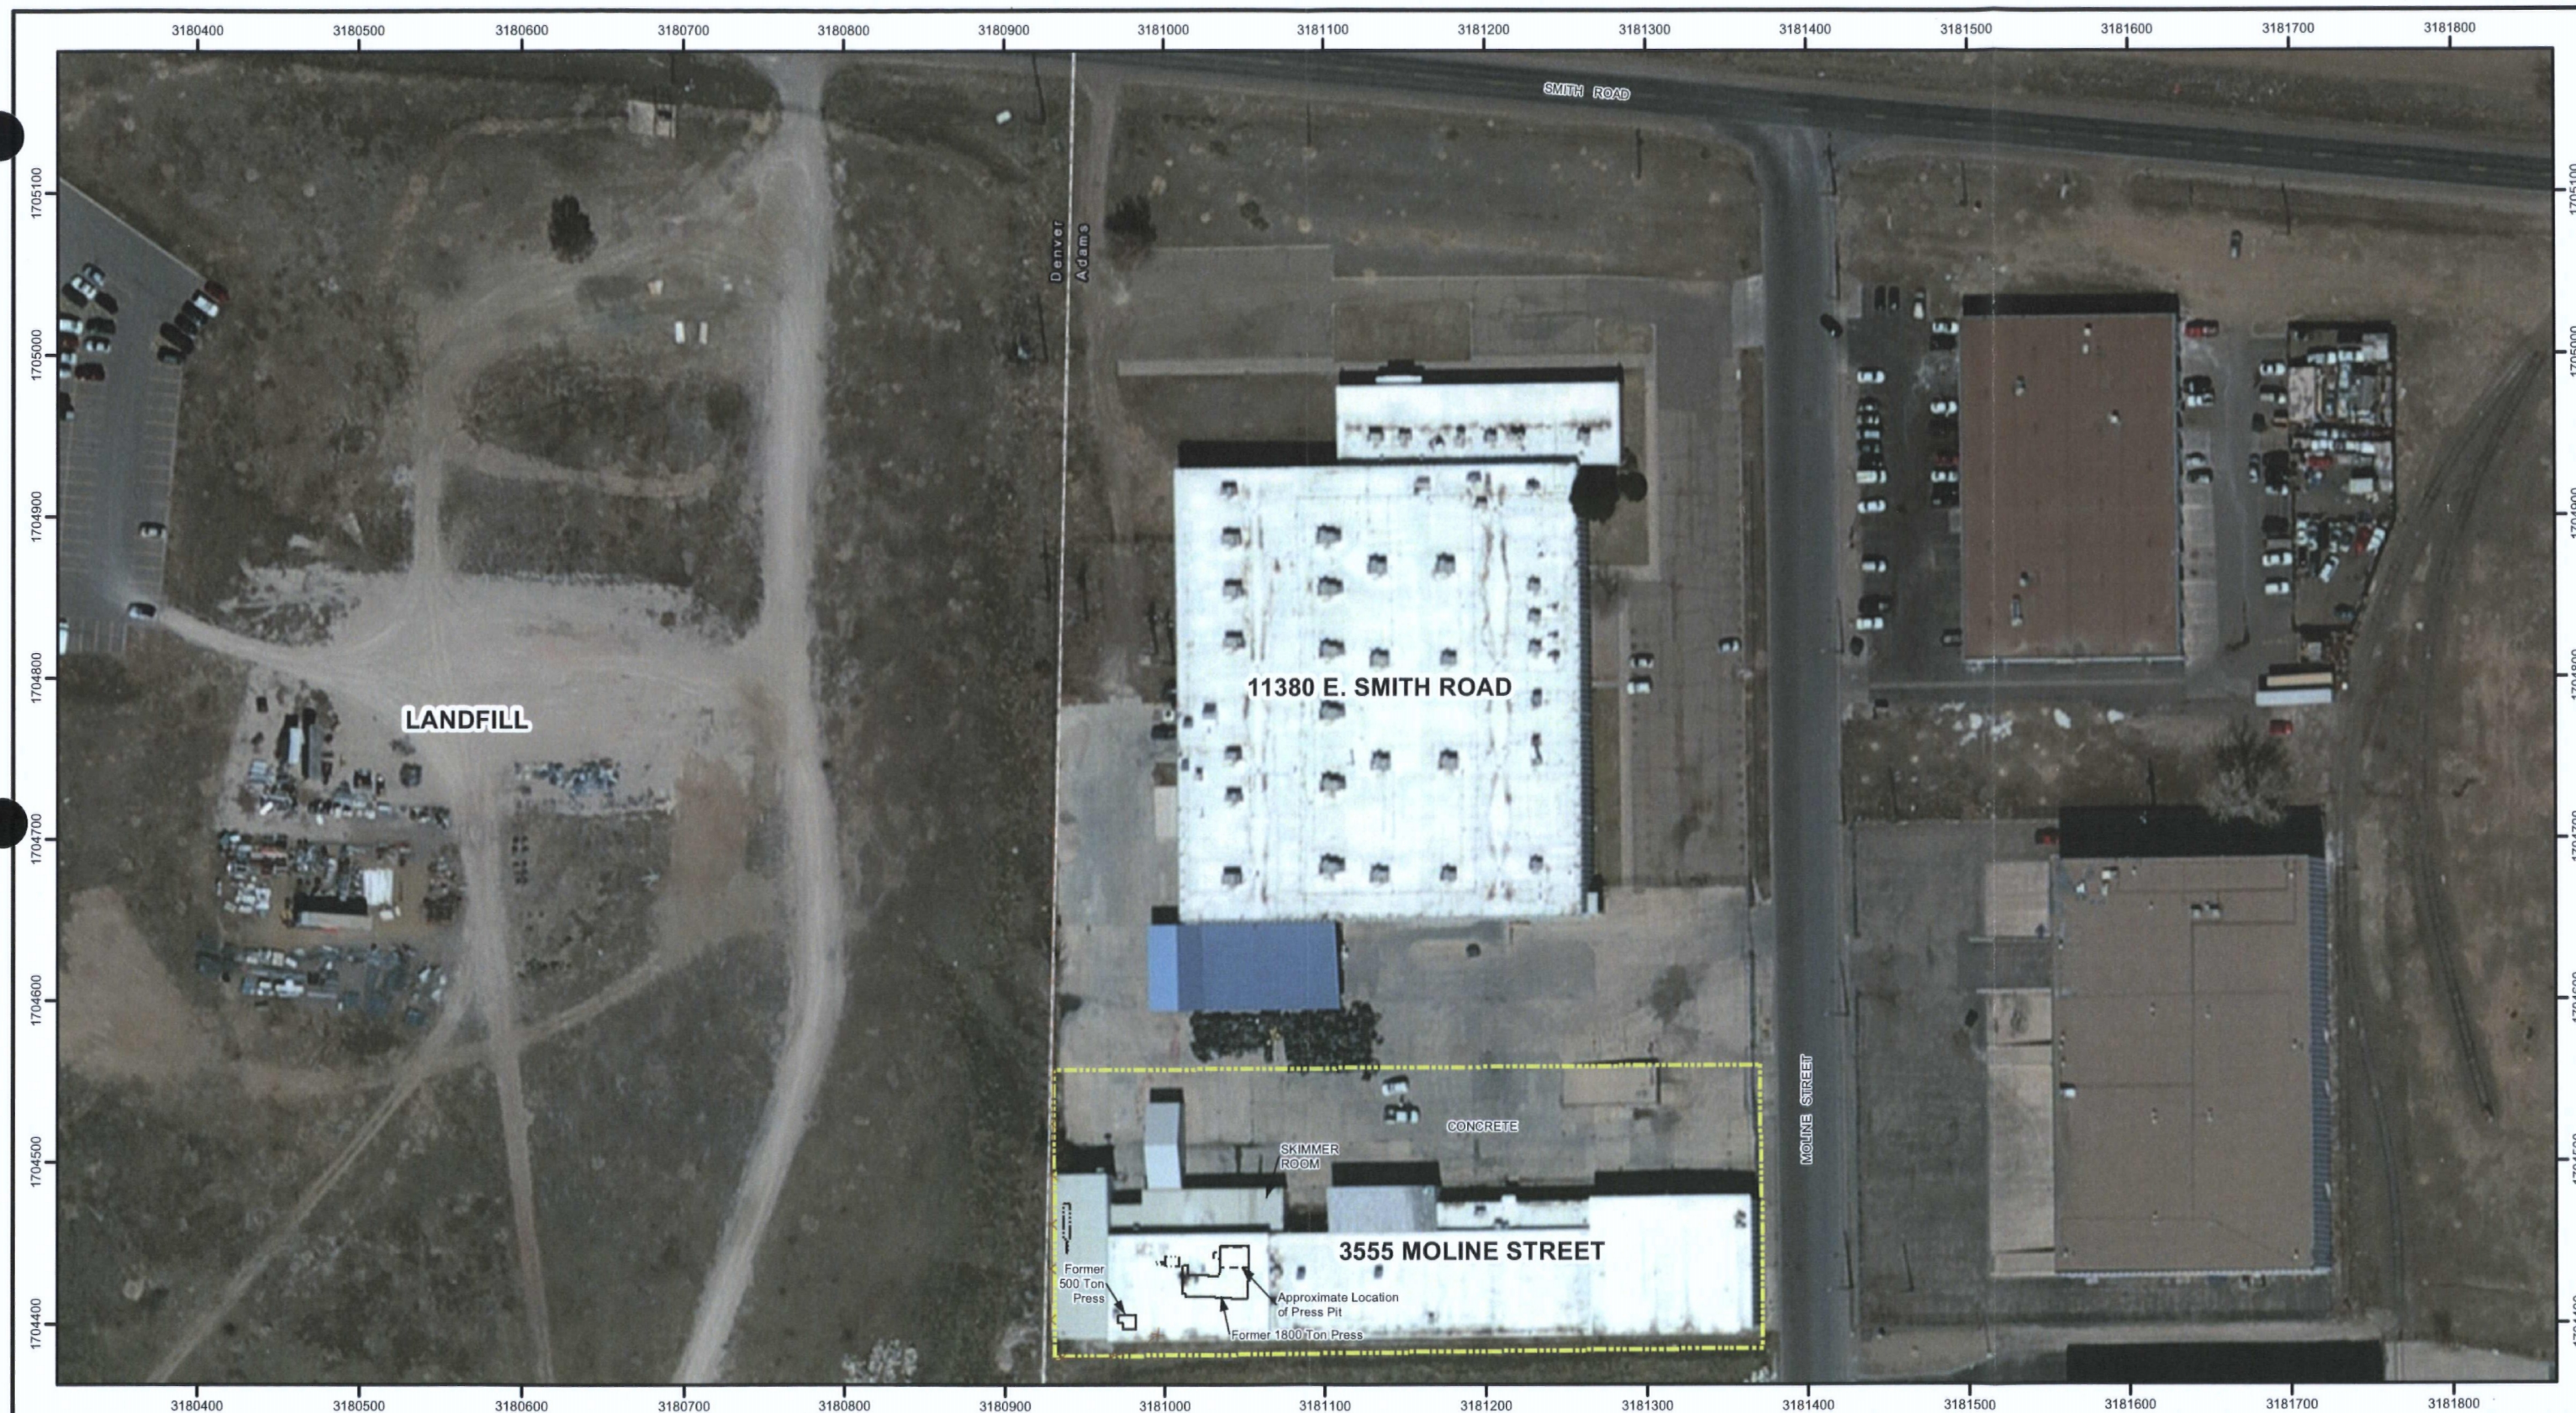
Figure 2 SITE VICINITY

- Property Boundary
- Former Press
- Press Pit
- Unidentified Feature
- Surveyed Feature
- Fence

The Site is located in Aurora, Colorado near the southwest corner of the intersection of Smith Road and Moline Street (Figure 1). The Site covers approximately 1.8 acres and includes a building with an address of 3555 Moline Street, as shown in Figure 2. The Site has an elevation of approximately 5,300 feet above mean sea level (amsl) and is relatively flat, sloping slightly to the southwest toward Sand Creek located approximately 2,000 feet south of the Site.

Figure 2 shows the Site vicinity. The removal action area is part of a larger property, which includes two parcels with a building at 3555 Moline Street (the Site) and a northern building with an address of 11380 East Smith Road with a combined property size of 5.7 acres. The property was developed from 1960 through 1972 and included the two buildings, paved asphalt parking lots to the north and east, and paved concrete storage areas between the two buildings. At the time of the removal action, the northern building (11380 East Smith Road) was occupied by Hi-Tec Plastics, Inc. (Hi-Tec), which operates a plastics recycling operation. The Site building (3555 Moline Street) has been vacant since 2009 and was purchased on February 14, 2014 by Hi-Tec as the Bona Fide Prospective Purchaser. Figure 3 identifies individual sections of, and attachments to, the Site building. For clarity when describing the activities, areas of the building have been labeled with designations of “Building A,” “Building B,” and so forth. Likewise, the excavation areas were sequentially numbered for clarity when referencing them in the documentation.

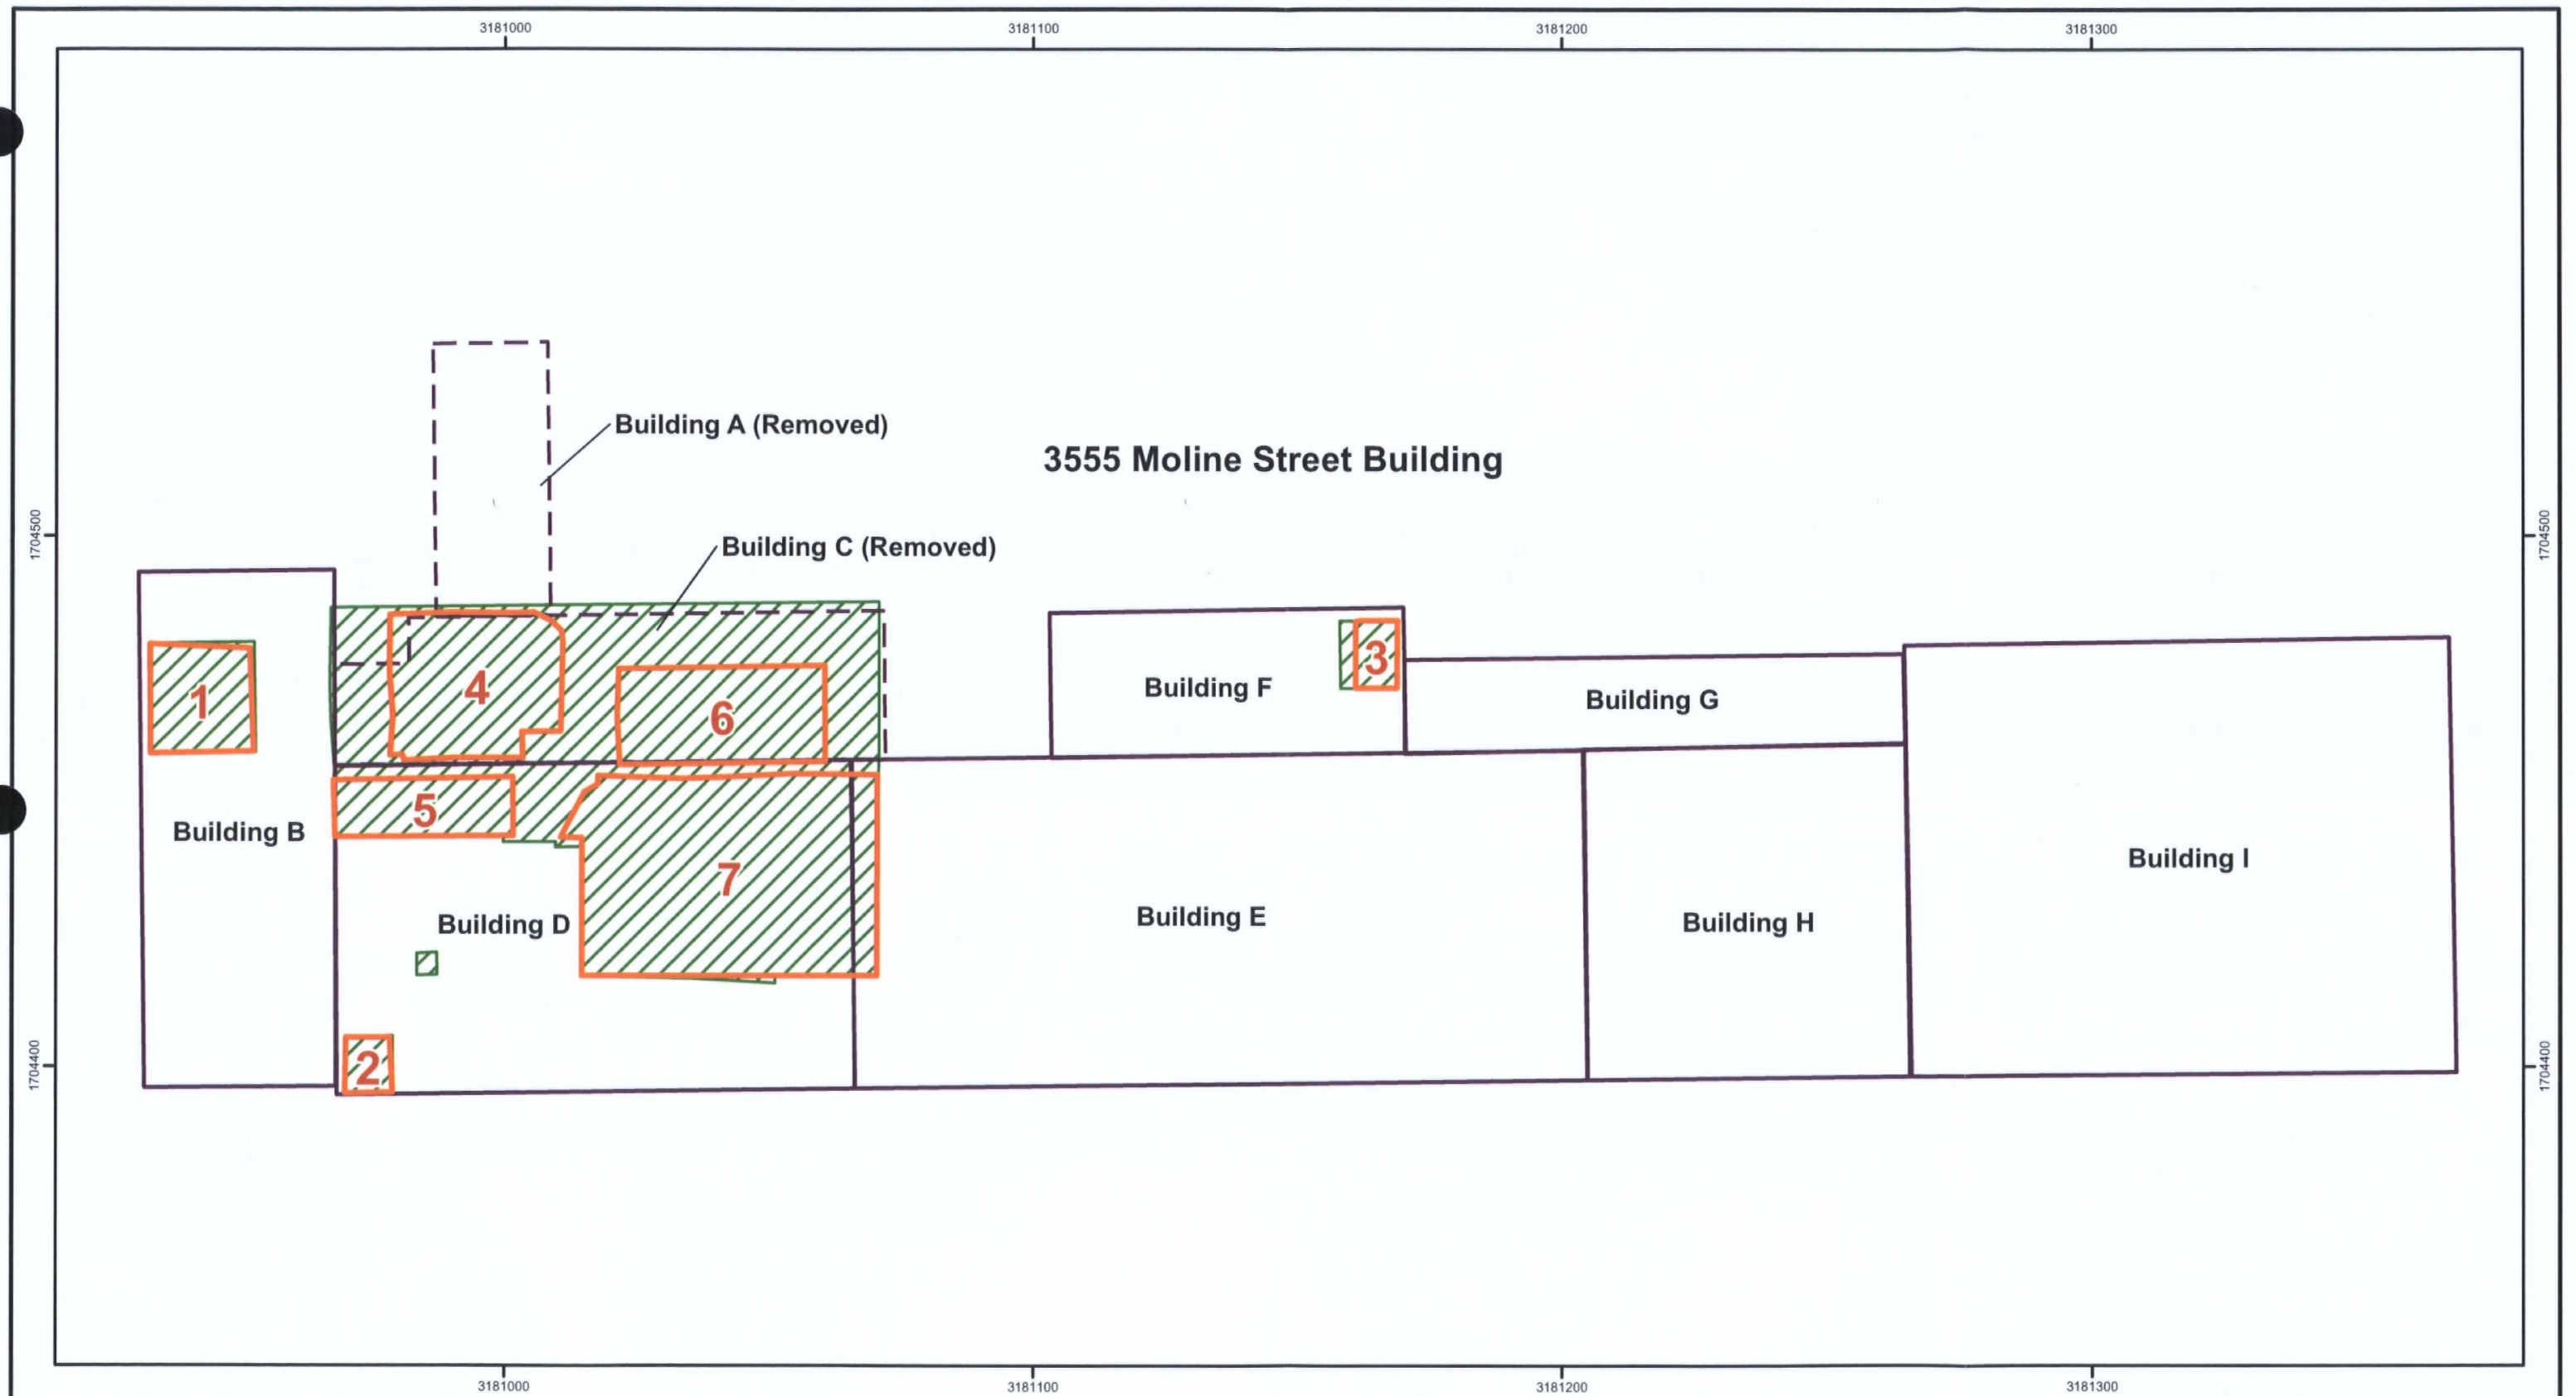
Figure 3 BUILDING IDENTIFICATION,
CONCRETE REMOVAL AREAS,
AND EXCAVATION LOCATIONS

- Excavation Area
- Concrete Removal Area
- Building Outline
- Removed Building Outline

Prior to commencing demolition activities, groundwater monitoring wells identified within the demolition area were properly abandoned to seal off potential conduits to the subsurface in accordance with Rule 16 of the Office of the State Engineer “Water Well Construction Rules” (2 CCR 402-2, 2005). Three wells were abandoned: BH-05, BH-06, and SMW-05. The saturated portion of the well’s screen interval was filled with sand and the unsaturated portion of the screened interval and the unperforated casing was filled with bentonite to ground surface. The upper portion of the well casing and well vault were removed during demolition activities and restored to approximately match surrounding conditions (concrete). Two of the monitoring wells were located within excavation areas and the third was located between excavation areas as shown by the concrete removal area on Figure 3. URS prepared submitted the well abandonment forms, and these are included in Appendix B.

Concrete was sawcut, demolished, and removed in areas where soil was to be excavated, or where total PCB concentrations in the concrete exceeded clean-up levels during the Stage I investigation. Concrete removal areas are shown on Figure 3. Concrete sampling is discussed in Section 2.5 and Table 3.

Soil was excavated in seven different excavation areas inside Building B, D, and F, and outside of the building after Building C was demolished and removed. The excavation locations are shown on Figure 3.
